EPA Requirement - Mechanical Integrity Testing (MIT)

Troubleshooting a problem completion

Qualitative Production Index and High Perforation Count Analysis

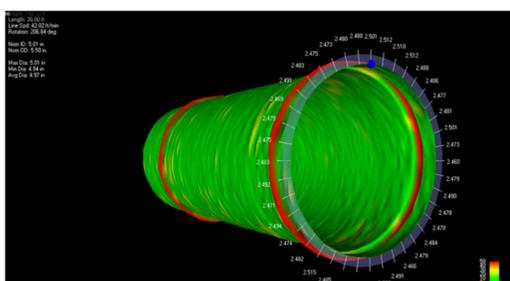
Casing Inspection using Multifinger calipers will not only find leaks that pressure testing will expose, but will also find areas that are likely to leak soon based on casing wall loss or pits that may eventually penetrate. This first casing inspection is an obvious example of very severe casing degradation.

These examples are from the video that is supplied with the analysis report. The user can change many aspects of the video and put it in motion to move up and down the well. At 150', this casing has light/moderate ring damage and light/moderate corrosion.

Figure 1 from page 1 grading is 2, moderate—light ring damage, moderate corrosion

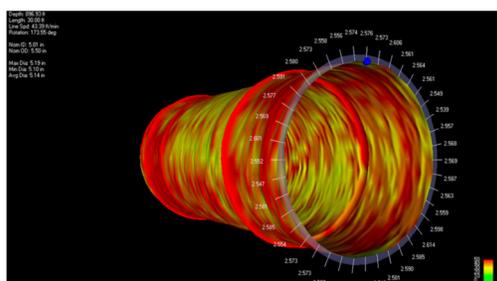
At 270', the casing has moderate ring damage with heavy corrosion and pitting.

Figure 2 grading is 3, moderate ring damage, heavy corrosion

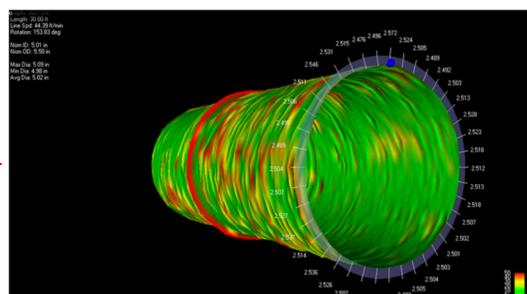
At 895' the casing has multiple holes and heavy ring damage and corrosion

Figure 3 grading is 5, Heavy corrosion, heavy ring damage, hole penetration

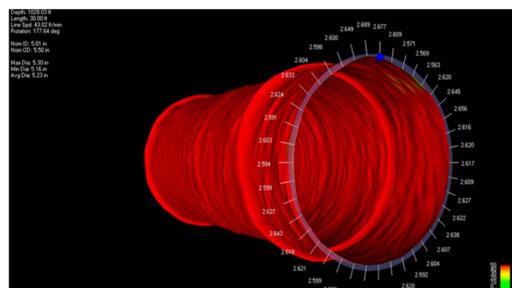
At 1028', the casing is heavily corroded with massive metal loss and holes.

Figure 4 grading is 5, heavy corrosion, ring damage and hole penetration

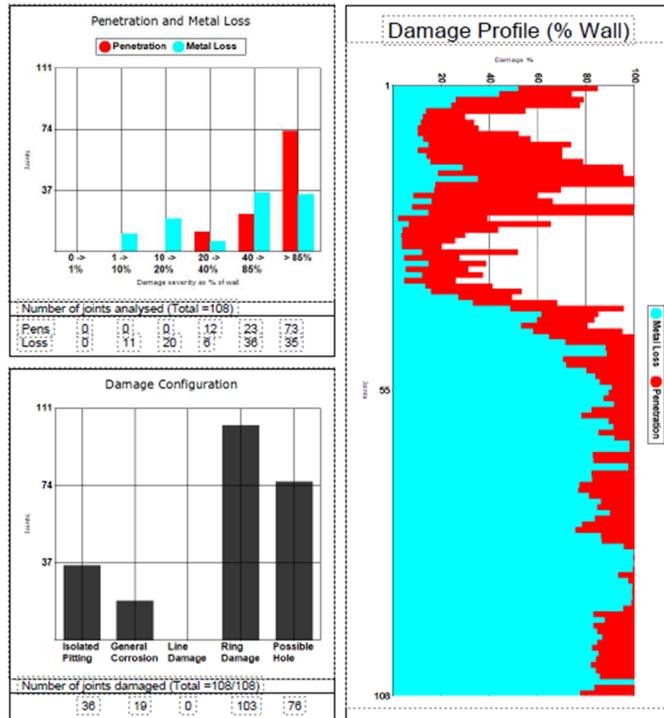
Joint Metal Loss and Penetration

Wall penetration is evident in the first 15-25 joints, before becoming consistent in the joints below 880 feet

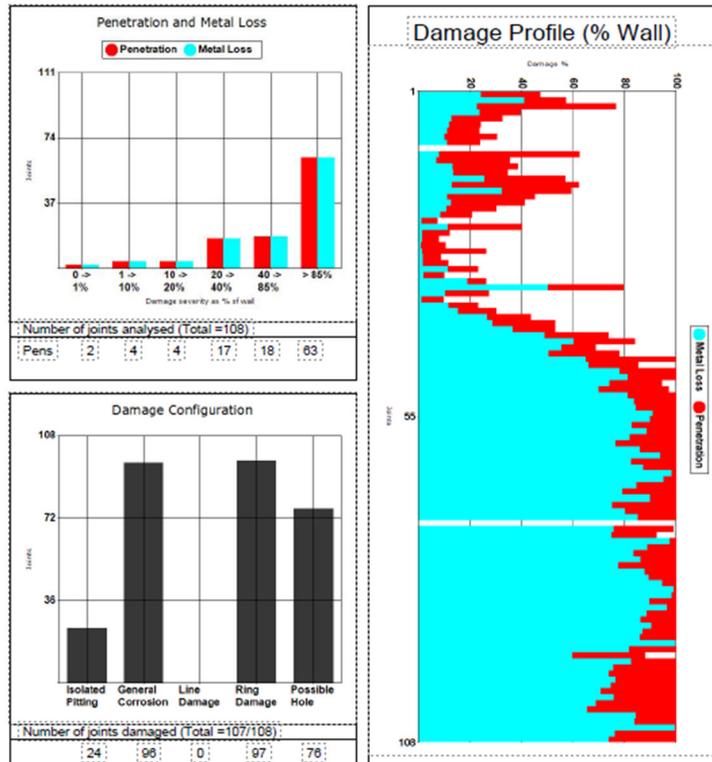
Collar Metal Loss and Penetration

Collar penetration is evident in joints below 880 feet.

Scaling and buildup is also evaluated but not shown here as it is very minimal

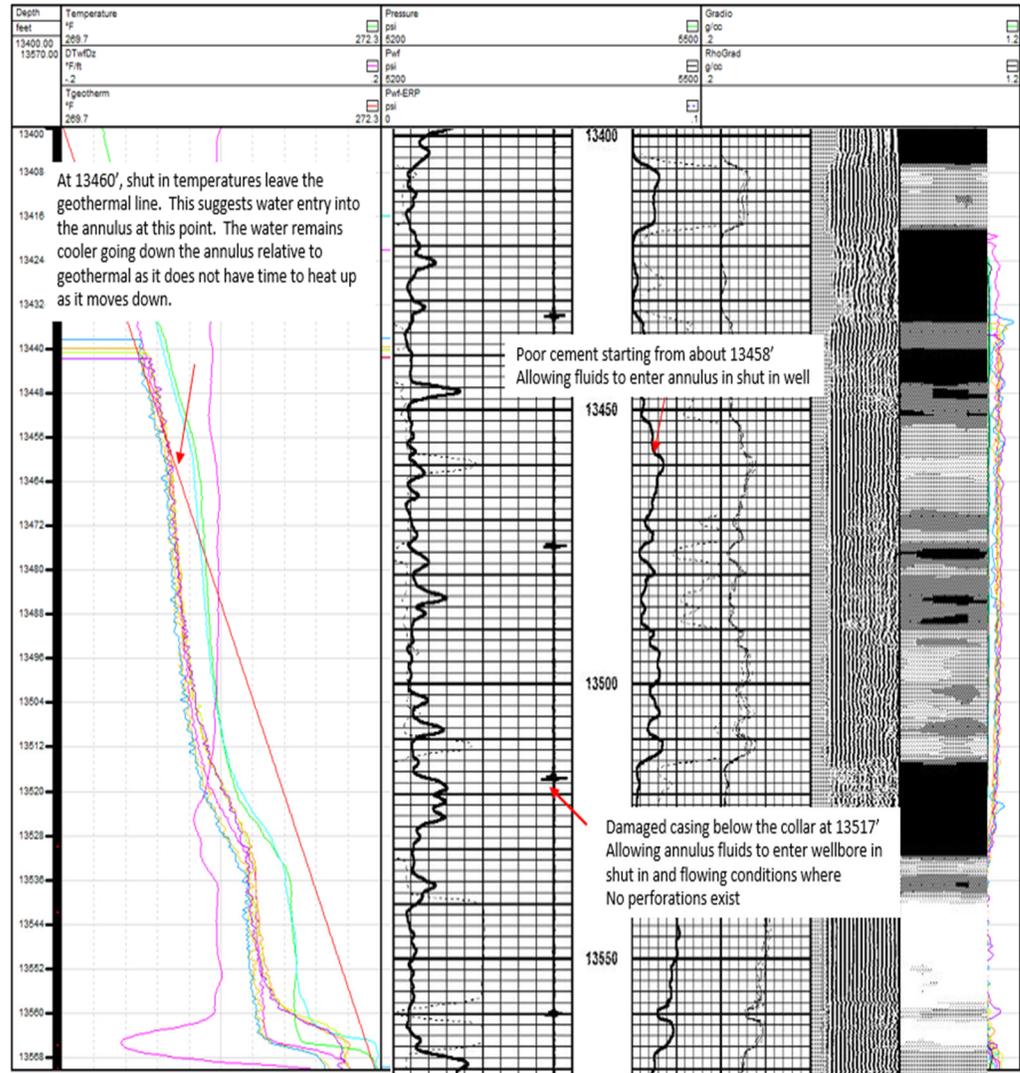
Figure 1

At approximately 13460', the temperature acquired while the well was shut in deviates from the geothermal. A bond log indicates poor cement from about 13458' down the well to good cement at about 13515'.near a collar at 13517'

The bond log information indicates that poor cement allows fluid to move in the annulus and casing in the poor cement between the points of good bond at 13458' and 13516'. The shut in temperature indicates that this is occurring.

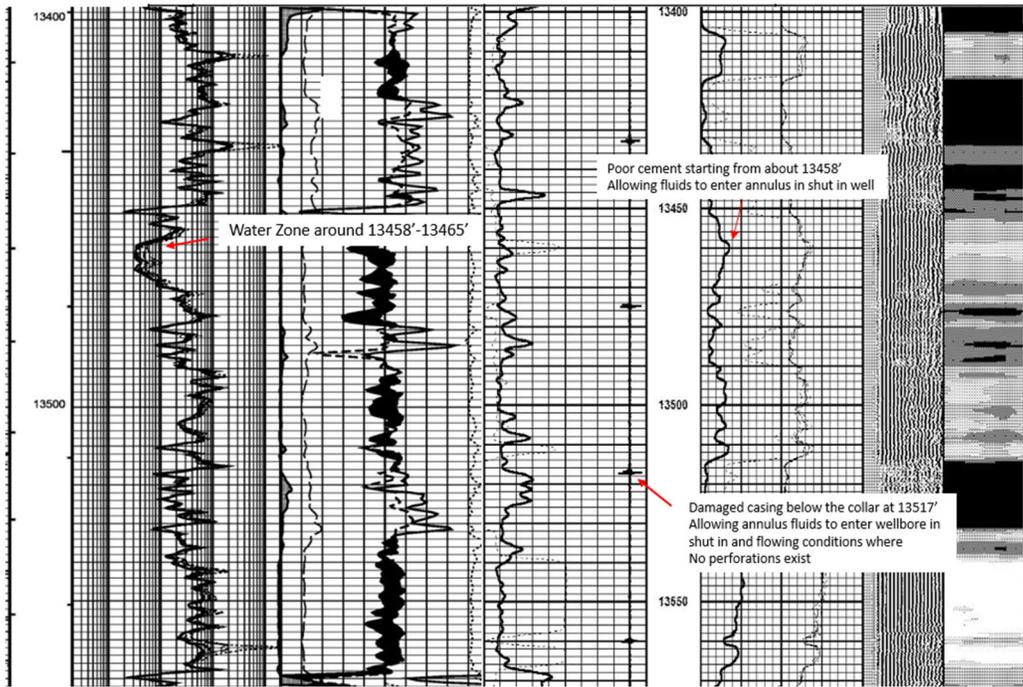
Figure 2

An open hole log was referenced in this well. A water zone from around 13458'-13465' is apparent from the open hole log. This zone is adjacent to where the poor bonding starts at 13458' as shown on the bond log (Figure 2)

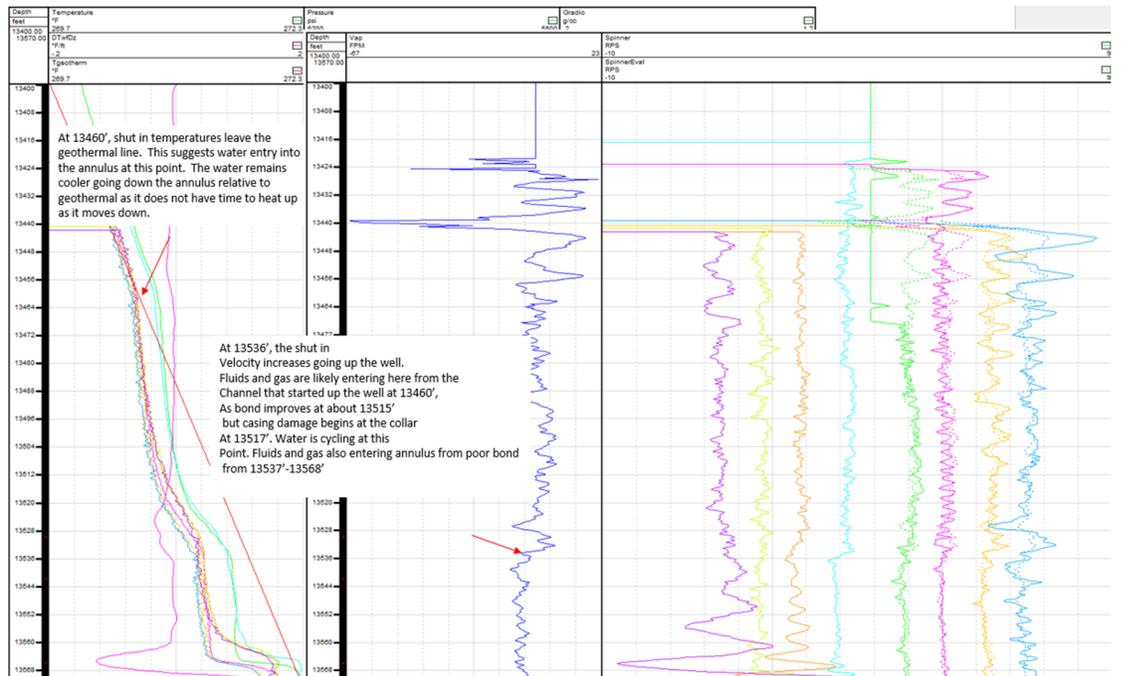
Figure 3 demonstrates the shut in passes made with temperature, spinner and calculated velocities shown.

At 13460', the zero velocity increases going up hole, indicating entry of fluid from the annulus at this point. No recorded perforations here. This is fluid reentering the wellbore from damaged casing as the fluid is sealed off from further descent in the annulus with the return of good cement bond

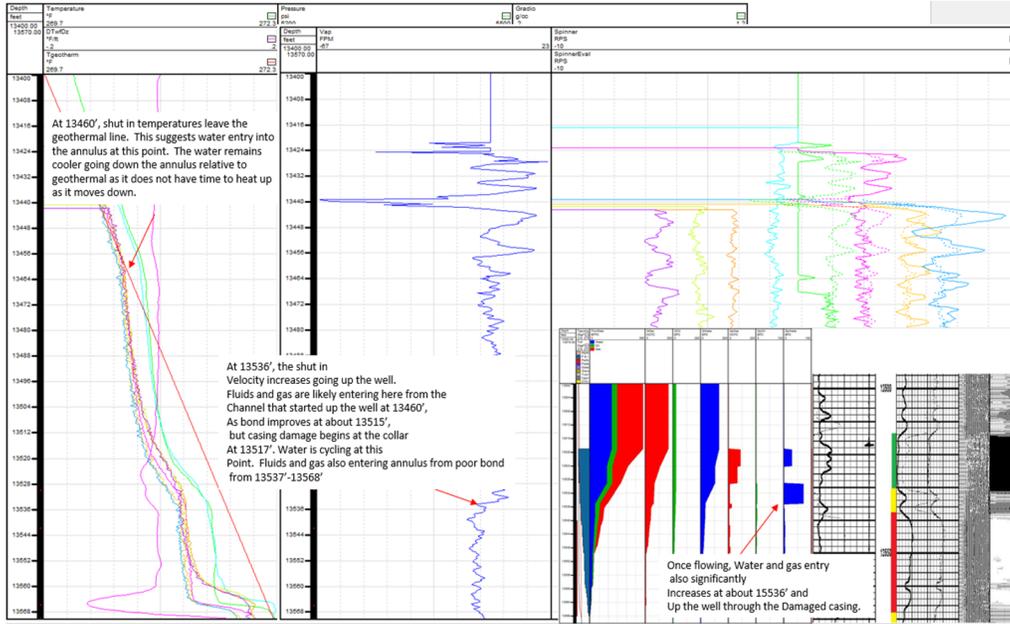
Figure 4

Once the flowing passes are made, the profile indicates a significant increase in water and gas entry at about 15536' and up the well through the damaged casing. The shut in temperature indicates the deflection at this point, indicating increased production above this point as well (not enough time has passed to allow shut in temperature to completely return to geothermal)

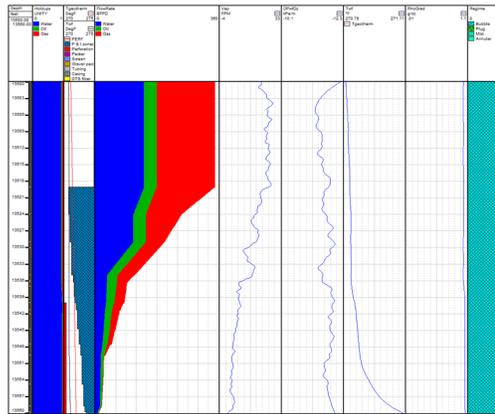
Figure 5 illustrates the flow profile with added entry through damaged casing above perforations

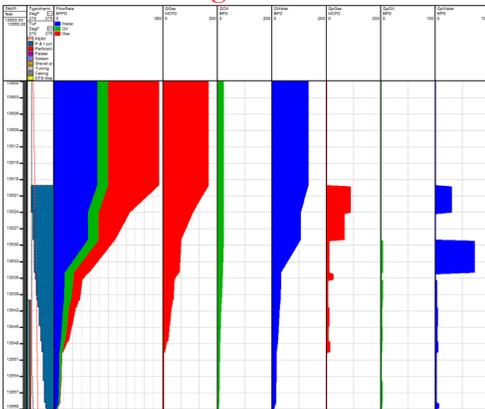
Figure 6 indicates quantitative phase entry

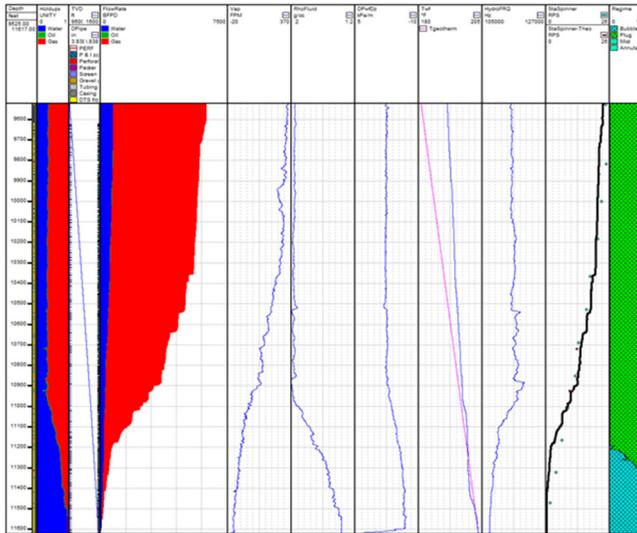
Figure 1 Run 1 Profile (Qwater=711 BWP, Qoil = 20 BOPD, Qgas = 2999 MCFD)

Well choked to a pressure of 656 whp at surface (run 2), produces a lower water cut and likely a better ultimate recovery as the vertical conformity is more consistent and production is better across the qualitative higher PI intervals as shown on next page

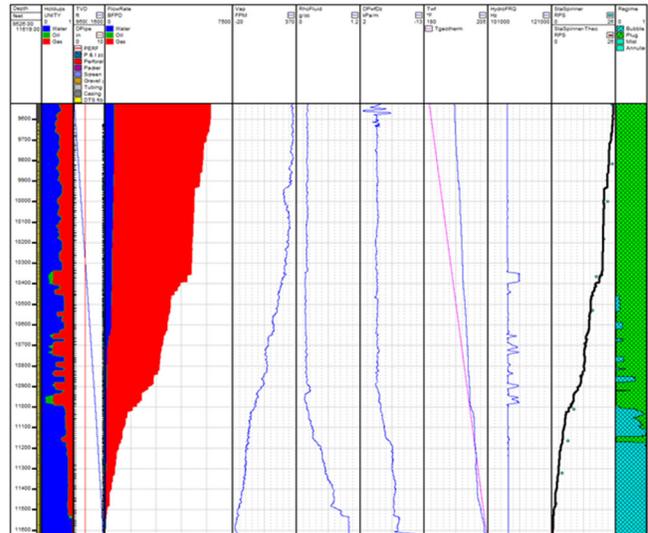
Figure 2 Run 2 Profile (Qwater=500 BWP, Qoil = 15 BOPD, Qgas = 2416 MCFD)

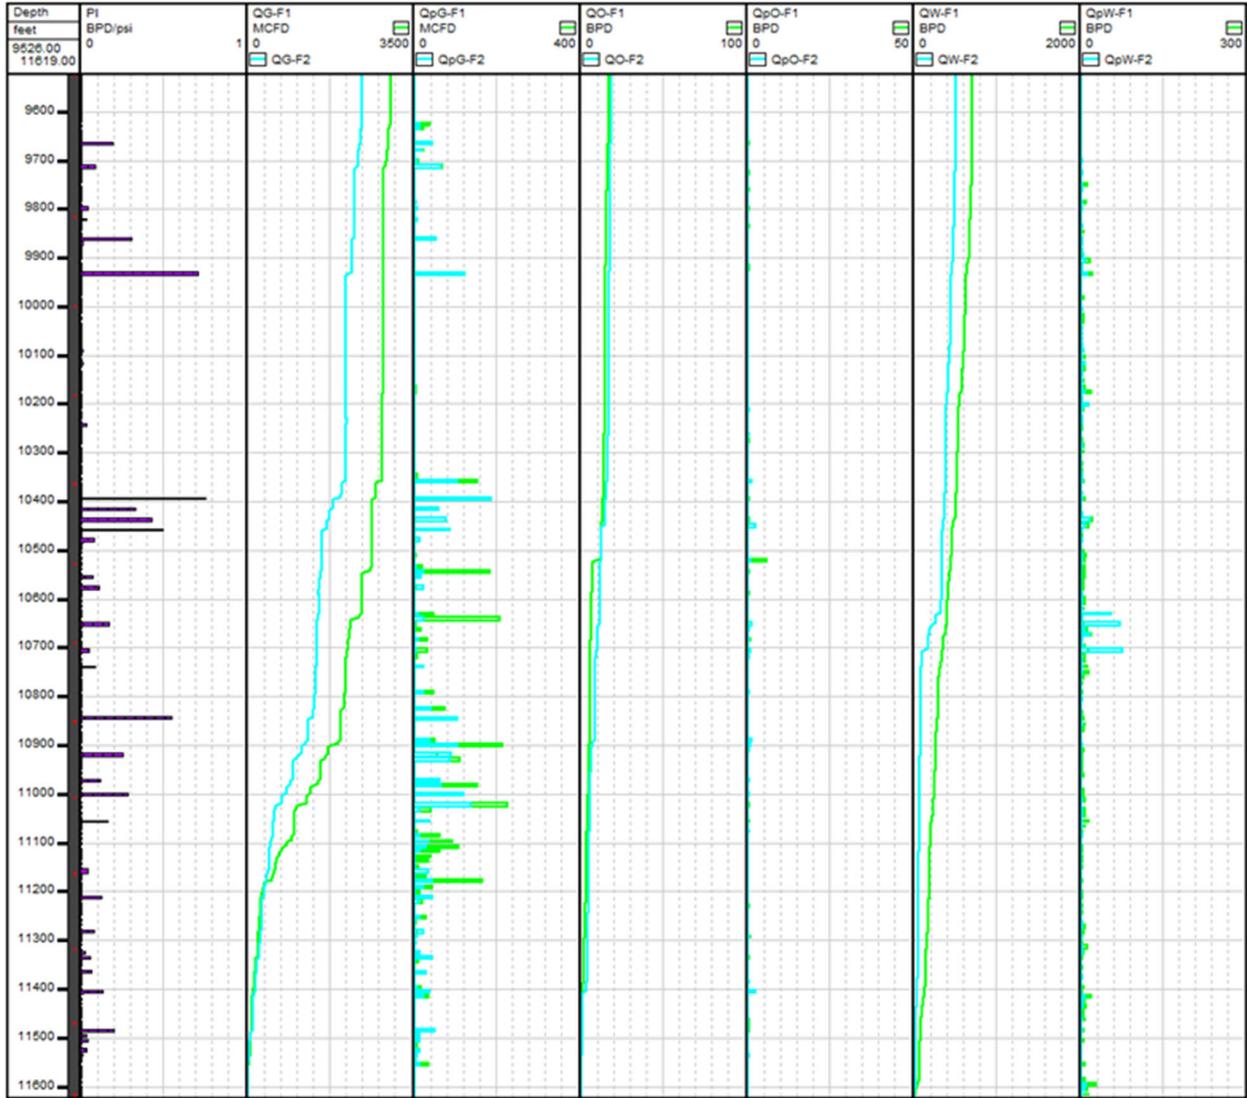
Figure 3

Production Index Gas Profiles 1&2 Gas Entry 1&2 Oil Profiles 1&2 Oil Entry 1&2

Water Profiles 1&2 Water Entry 1&2

The Production Index is fairly constant and productive except for the interval between approximately 9950' to 10380'. Run 2 pressure will likely result in higher overall Ultimate Recovery

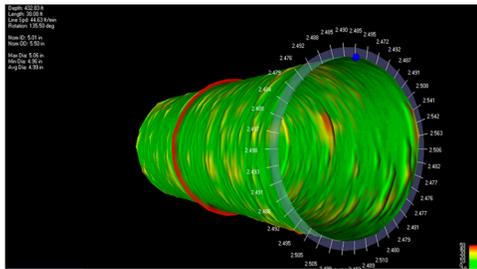
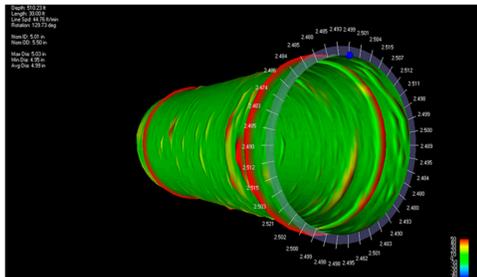
This casing looked very good for the most part, with only slight to moderate corrosion and pitting. No penetration or scaling seen. MIT passes, unlike the casing on page 1.
